BRUSH CREEK
HAYHURST VALLEY
YONCALLA

Watershed Analysis

First Iteration
11 April 1996

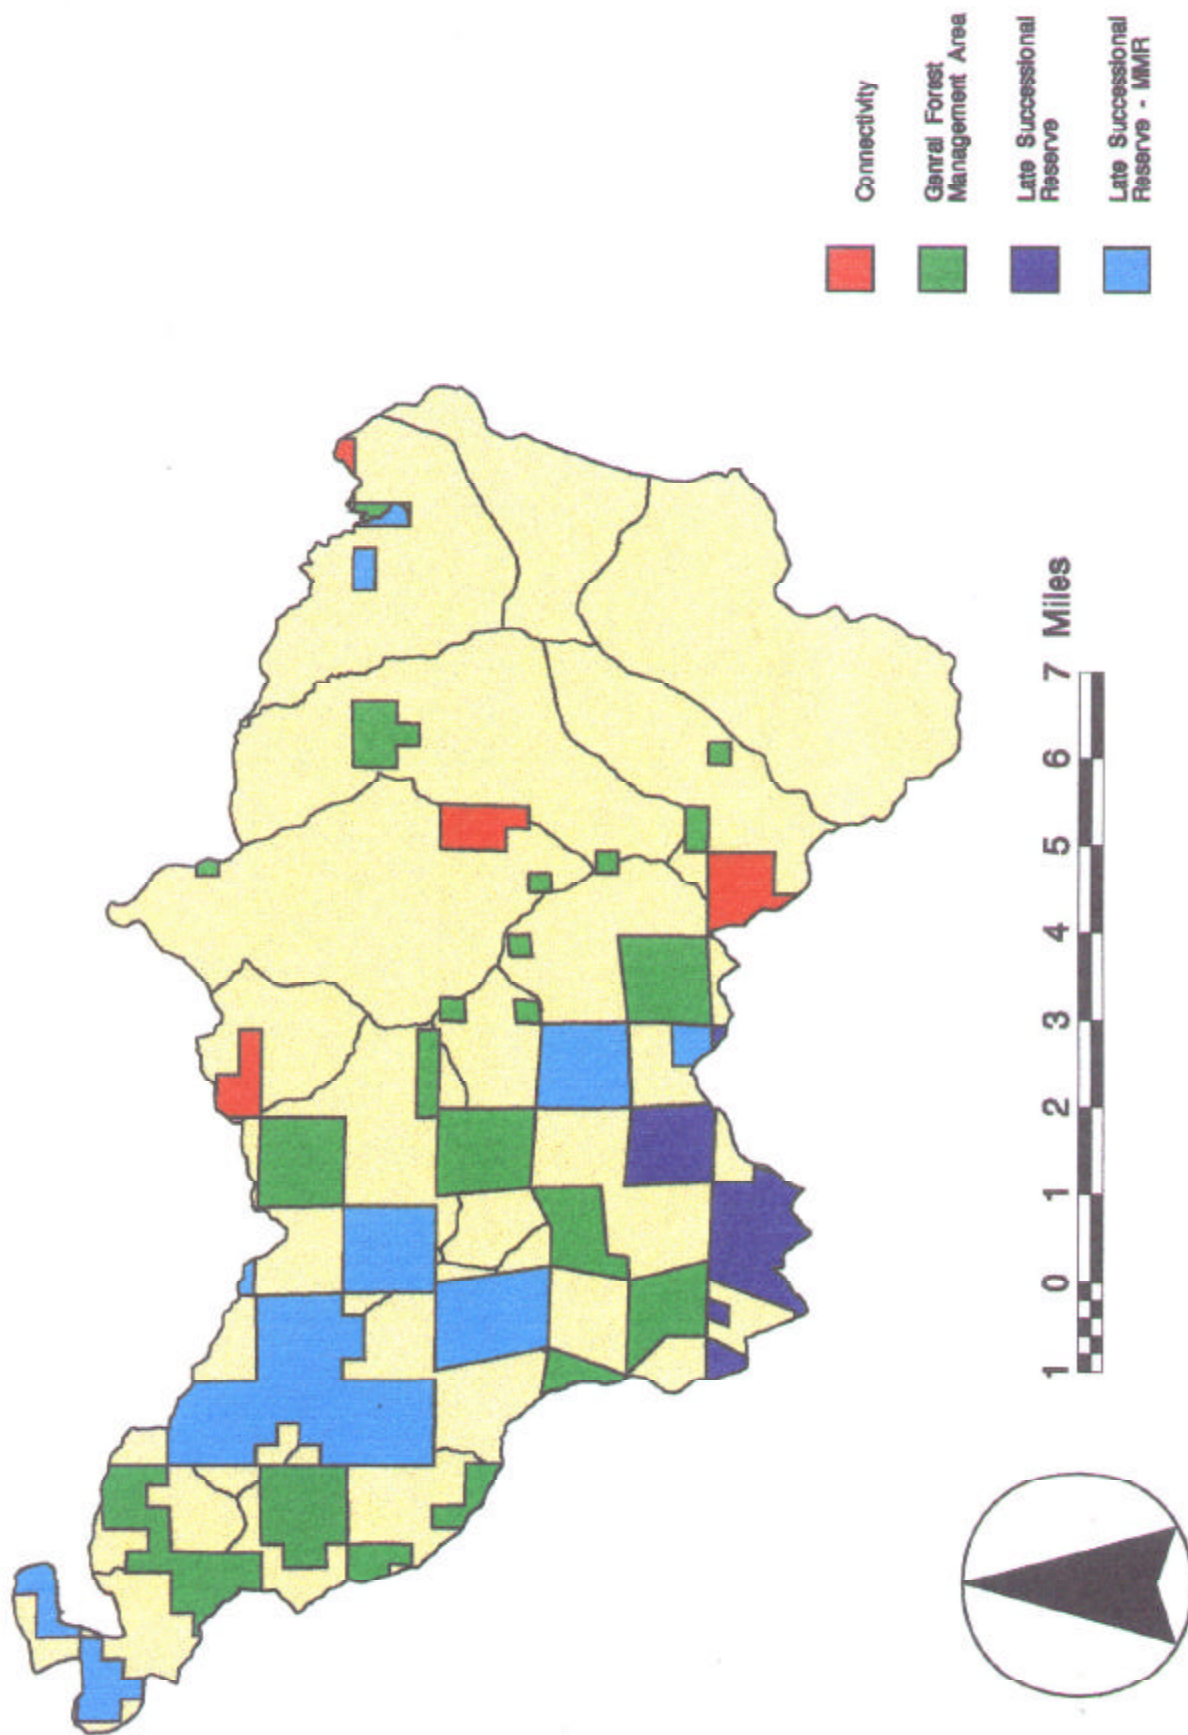
Figure I.1. Land use allocations within the BHY watershed analysis unit.

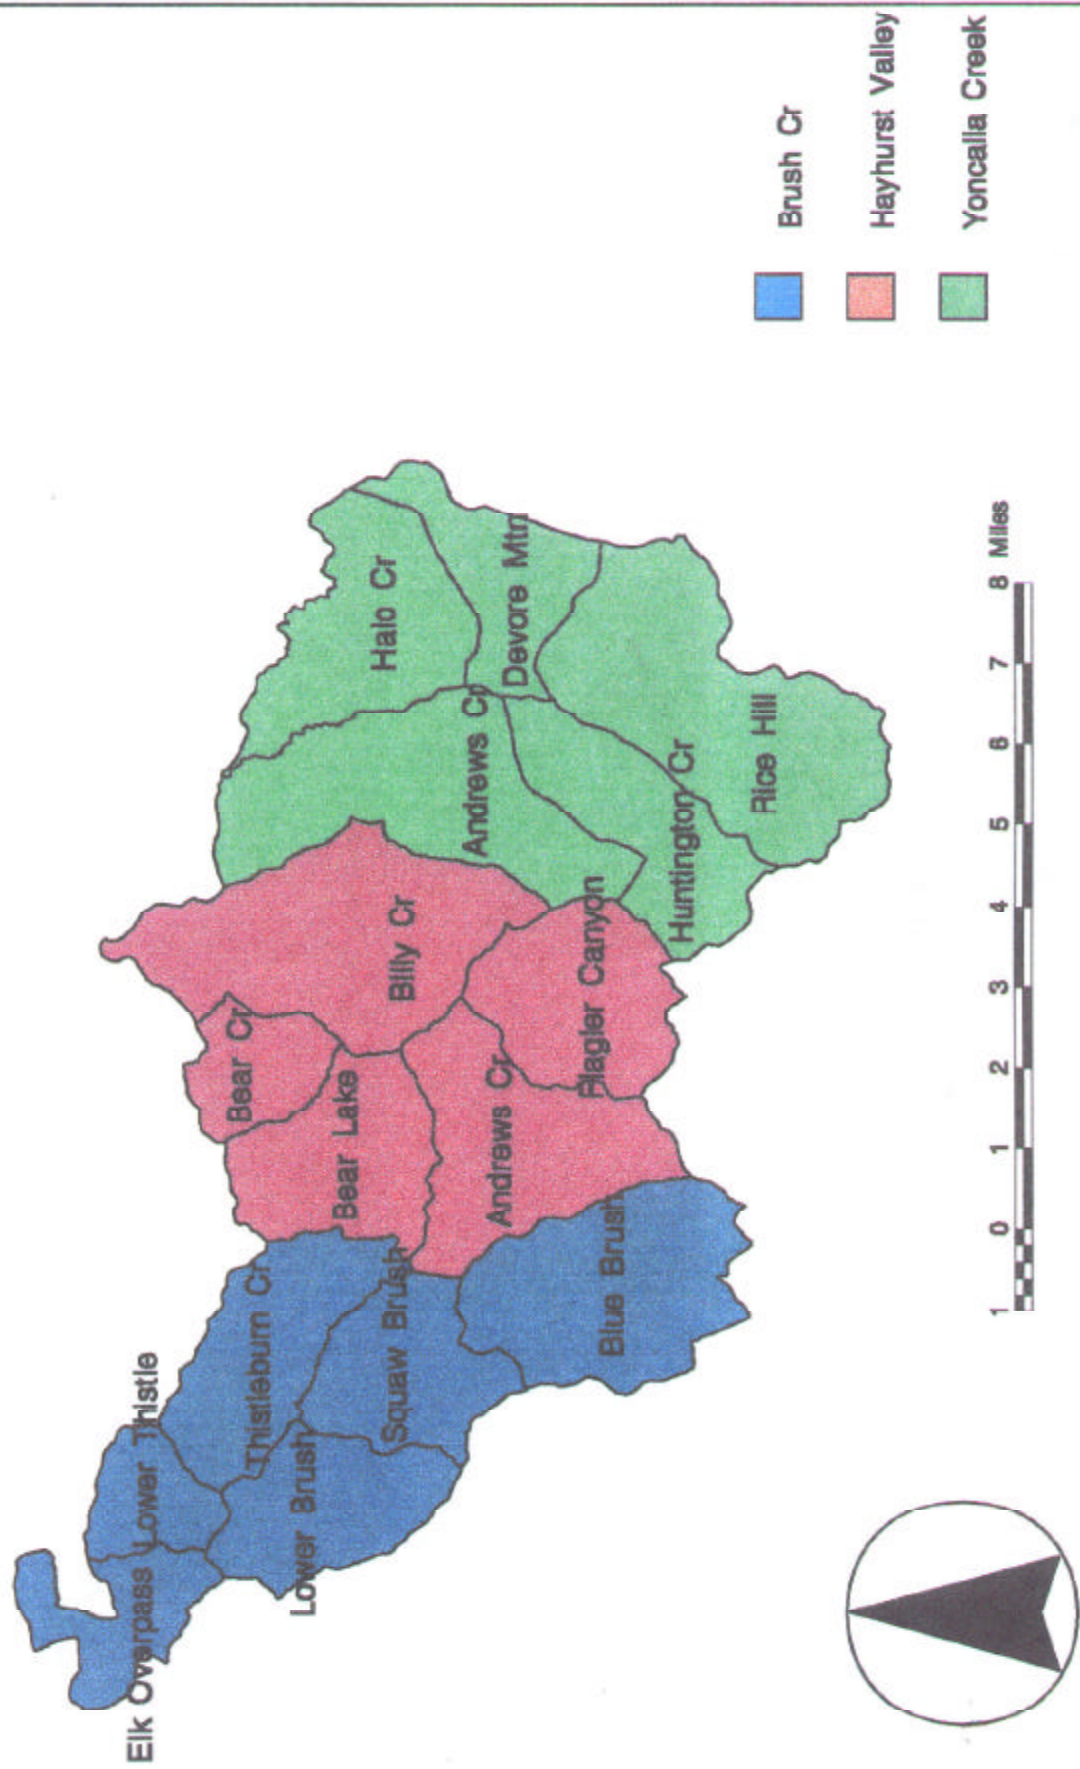
Figure 1.2. Watershed analysis units and compartments.

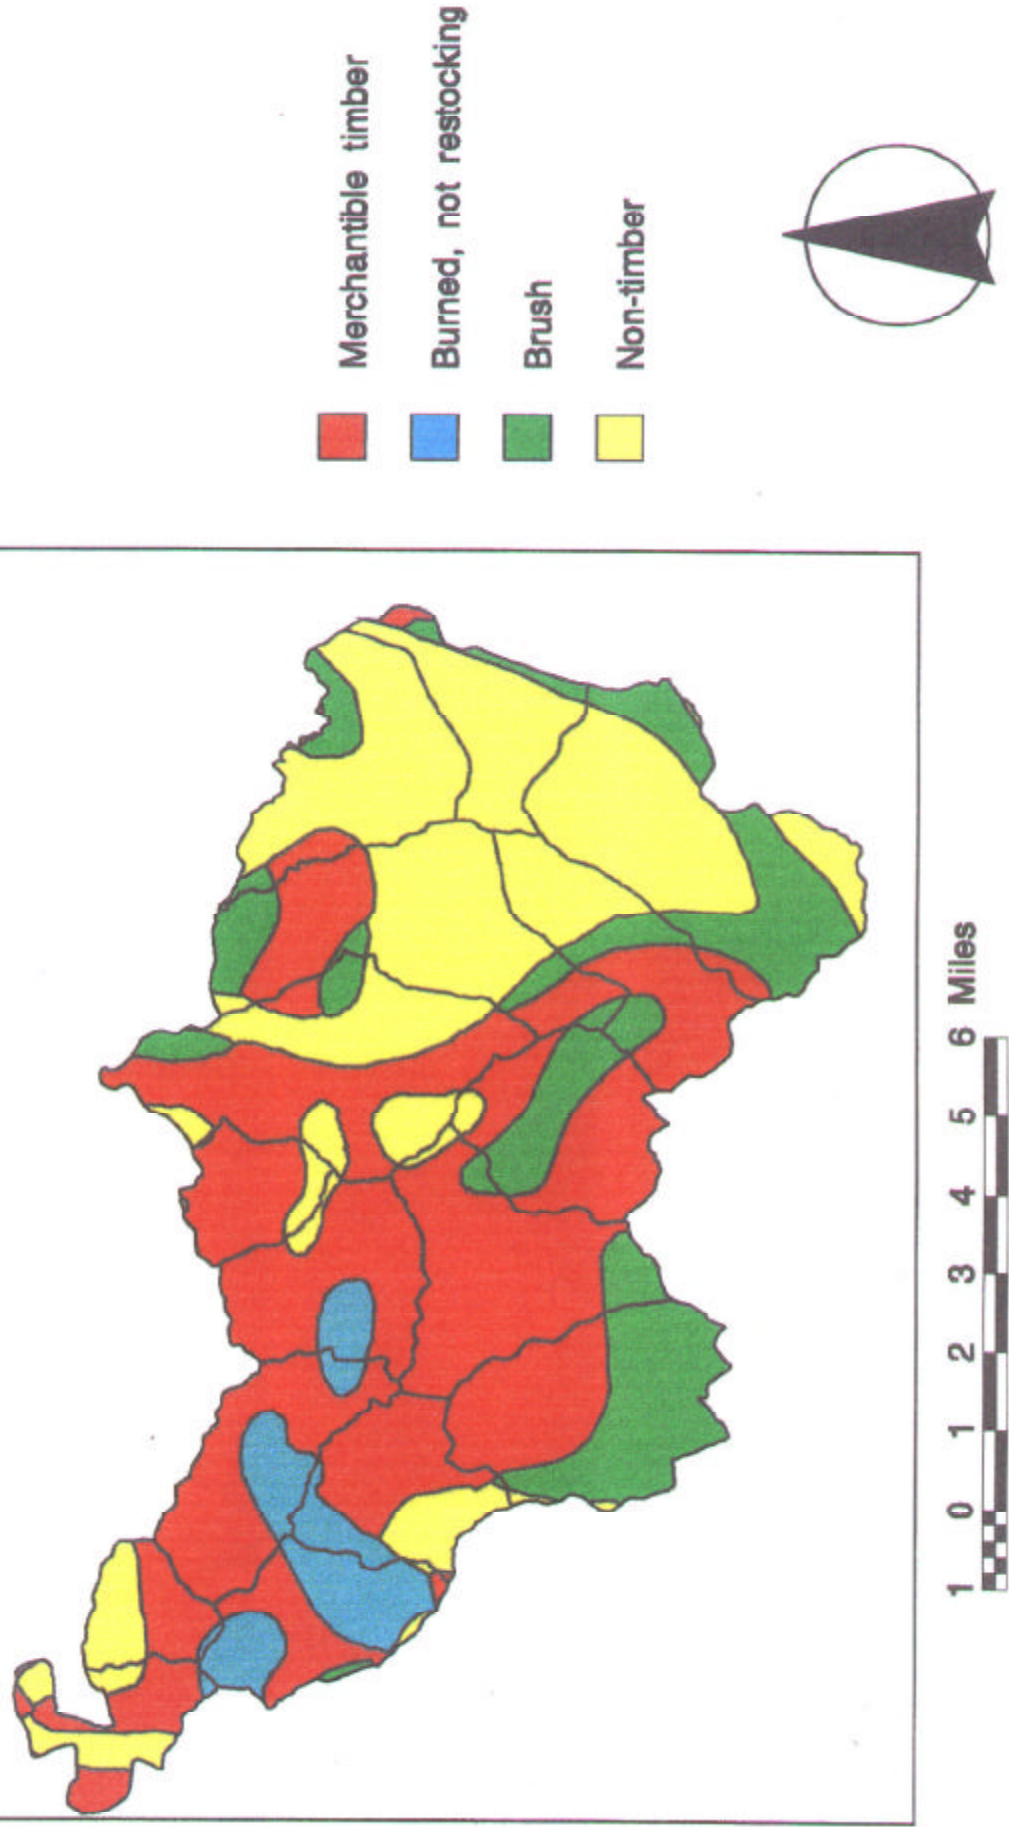
Figure I.4. 1914 Oregon state forest
type map within the BHY WAU.

The areas classified as "burned areas not re-stocking" are estimated to have had a stand

replacement fire that occurred 10-15 years earlier (Figure I.4). Many large fires occurred around the turn of the century. Approximately 6 percent of the BHY WAU was determined to be in this classification. These burned areas were probably the result of severe surface and crown fires. "Early season crown fires, or crown scorch fires in poor seed years, may be associated with a lack of early regeneration after a fire" (Agee 1993). In Coast Range forests, tree recruitment or re-establishment can take 50 years or more. Because of this, the fire that caused these burns may have occurred in the 1870's.

The areas classified as brush could have resulted from stand replacement fires that consumed the entire tree canopy (Figure I.4). Repeated burning by Native Americans may have eventually consumed all the conifers in these foothill areas. Perhaps there was no canopy to burn. The area may have been brush before. Regardless of the previous vegetation, this fire burned with high intensity leaving no seed source for conifer re-establishment. Brush sprouted from below ground adventitious buds and completely occupied the site. More recently, many of these areas have become reforested either naturally, or by conversion of brush to conifer stands.

The area classified as non-timber is mostly in the Yoncalla Valley and the surrounding foothills (Figure I.4). This area was likely grassland with a few scattered large trees, the result of repeated burning over long periods of time. The Native Americans used fire to improve forage for game animals and to improve habitat conditions for food and medicinal plants. Grasslands were burned in the summer. It must be assumed that some of these fires burned more than just the grasslands and sometimes resulted in the stand replacement fires shown on the 1914 map, perhaps creating "brush areas". Fires are known to have burned all summer until the fall rains extinguished them. "In all the low valleys of the Umpqua there was very little undergrowth, the annual fires set by the Indians preventing young growth of timber." (George Riddle 1851, as cited in Zybach 1994).

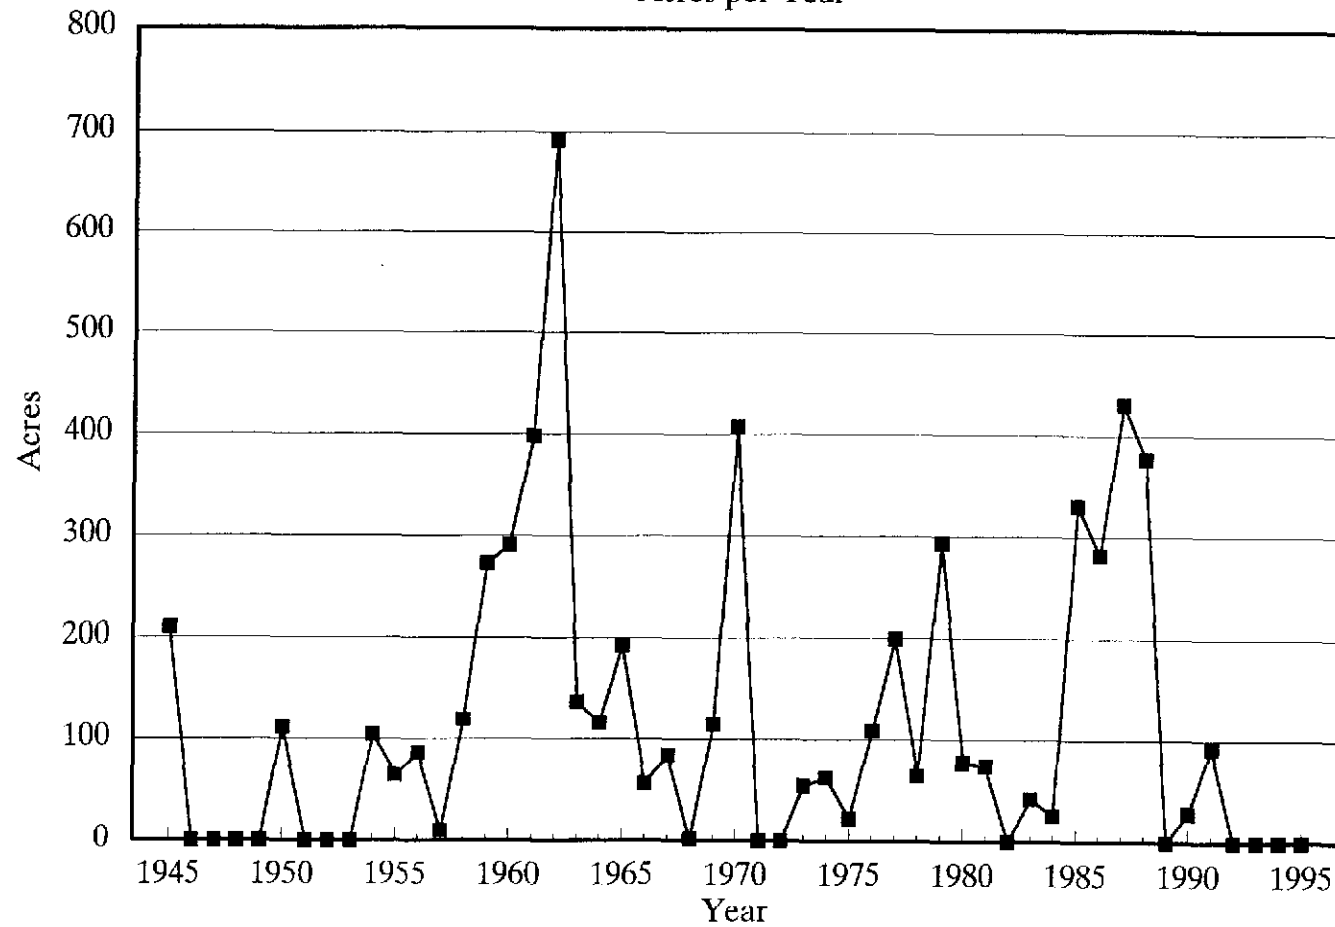
Figure IV.1

TIMBER HARVESTING BHY WAU

Acres per Year

The current age class condition of the Federal lands is mainly a result of two processes: logging and fire. Currently, the dominant influence on the age class distribution has been logging. Harvesting in a large scale started in the 1950's and continued up to 1990. Some small scale salvage and post sales occurred in the 1940's. The younger age class forests (1 to 40 years) are predominantly a result of clearcut logging and the subsequent regeneration of the logged areas. The regenerated areas are mostly in a patchy arrangement across the landscape that result from the staggered-setting arrangement of harvest units. Based upon the MicroStorms database, 197 units have been harvested in the watershed. Average unit size is about 30 acres, with harvested areas typically ranging in size from 5 to 50 acres. Before logging, fire was the major factor influencing the forest. Stand replacement fires have resulted in large (>100 acres) even-aged stands. Small gaps occur in these stands as a result of small scale disturbances such as disease, fire, and wind that have killed trees singly or in groups.

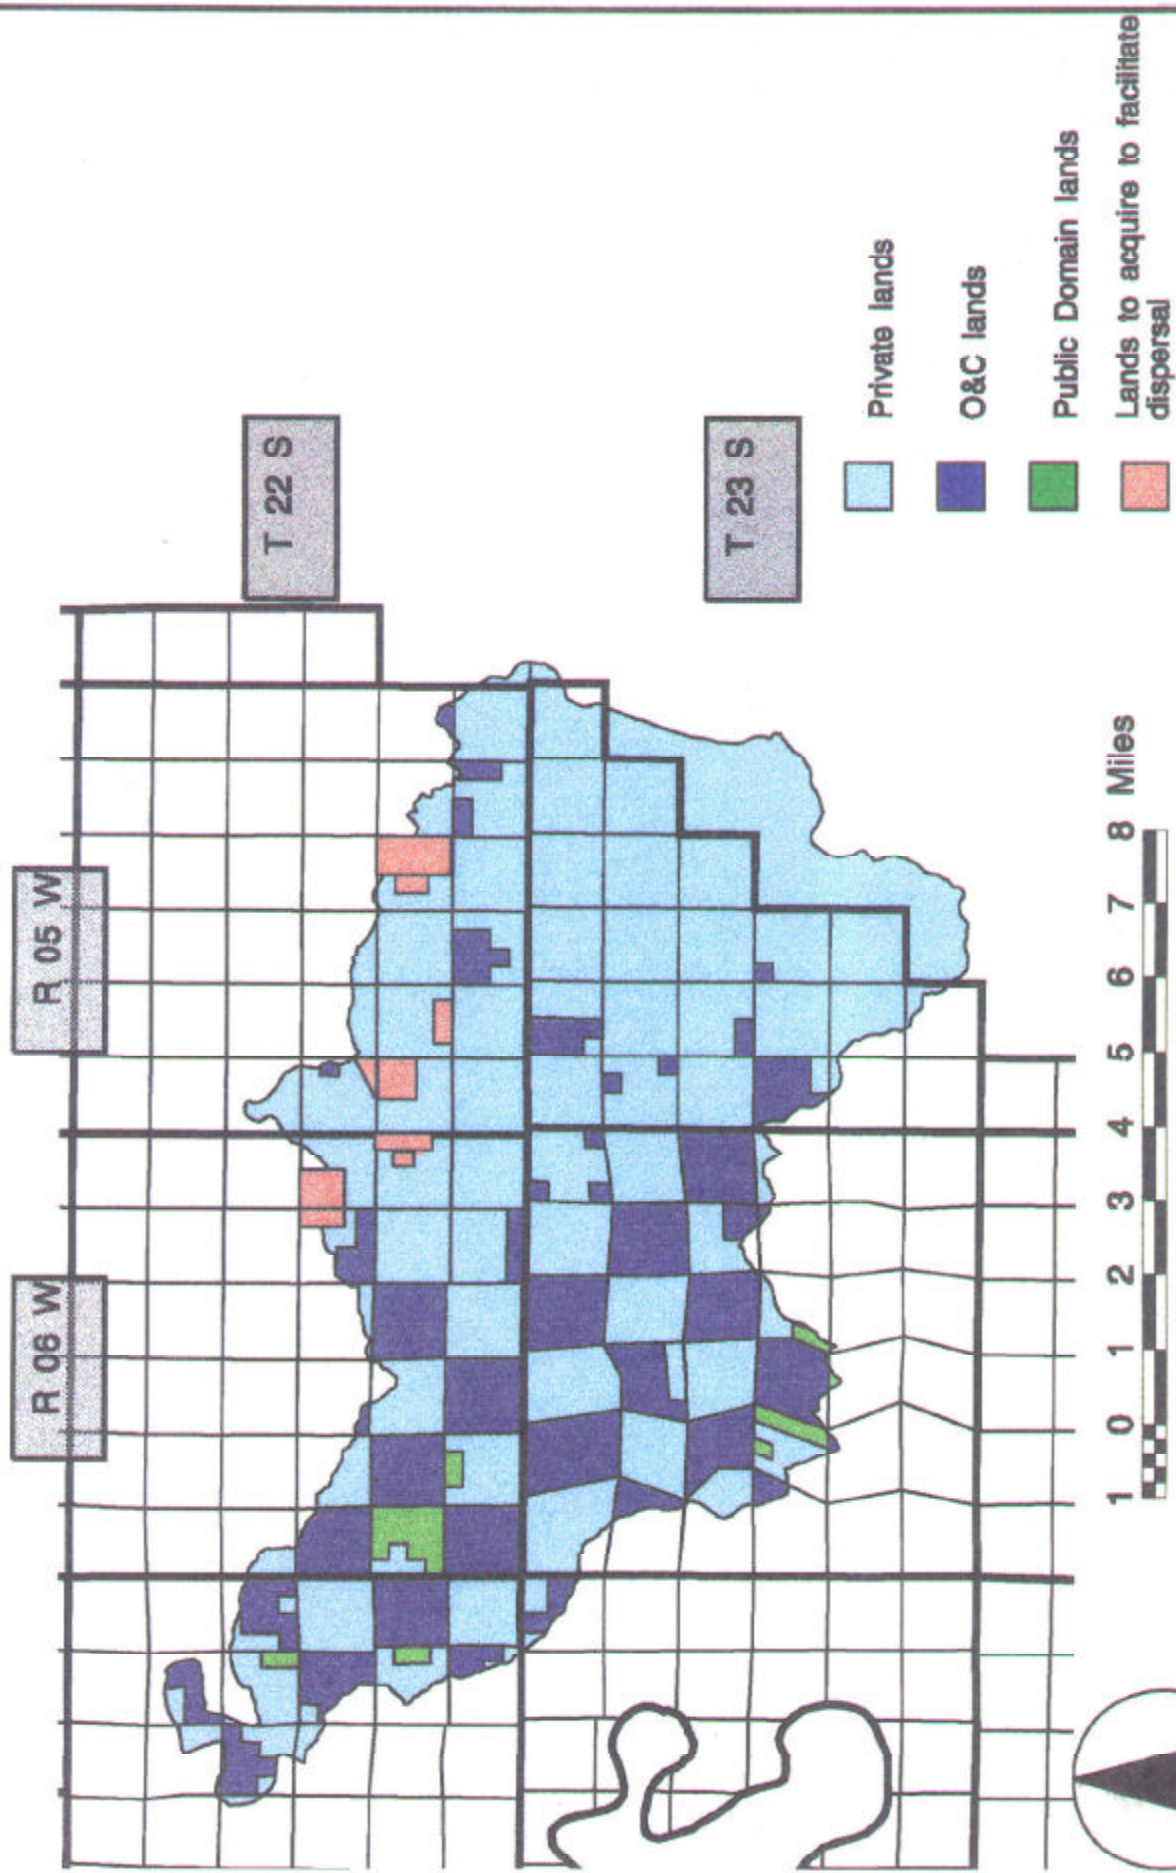
Figure IV.2. Possible acquisitions to facilitate dispersal between the Coast Range and the Cascades.

To improve habitat for the northern spotted owl will require that we improve its availability and distribution in the Yoncalla drainage; thereby, greatly improving the bird's ability to disperse between the Coast Range and Cascade Province. This idea is not designed to create independent sites or territories in the valley but to provide stepping stones between the two provinces. The recommendation is to acquire five patches of forested habitat between Drain and Yoncalla and manage them in the long term as connectivity (dispersal habitat to early suitable habitat) (Figure IV.2, Table IV.2). Acquisition should be prioritized to maximize the earliest benefit to the owl.
